Site Visit Report

Project: Contractor: Gristmill Village

GRAFTON, MA Prepared By:

GEI was on site to witness drainage installation on Millstone Drive as part of the Gristmill Village subdivision. Upon arrival, I met with Nick DiPilato to review the work. Today, the following was observed:

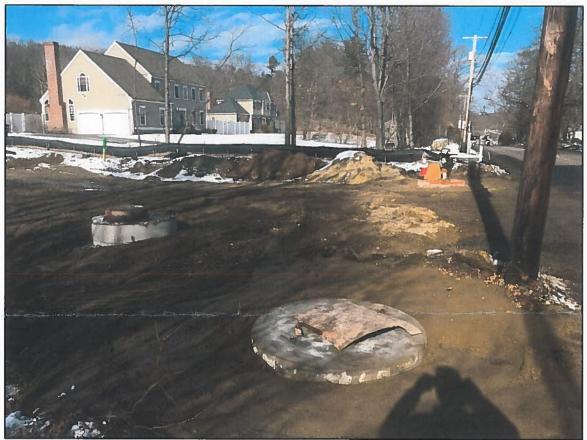
Structures were installed on a bedding of crushed stone and kent seal was installed between sections. The structures were being backfilled with the previously excavated soil (larger rocks and boulders found within the soil were sorted out before backfilling) and compacted using a vibratory plate compactor. Mr. DiPilato is planning to install the catch basins for the site first before installing any pipe or the remaining manholes.

Photo 1: Installed and backfilled CB-1, 2, and DMH-1 on Millstone Drive.

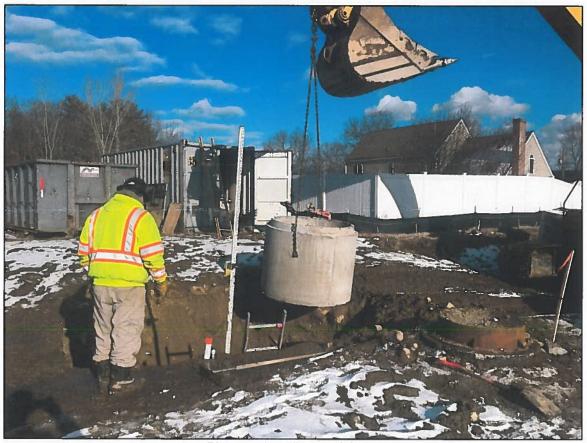
Photo 2: Installation of CB-4.
